# ***LESSONS LEARNED FROM PRESSURIZED UNDERFLOOR AIR DISTRIBUTION SYSTEMS***

***Presented At  
High Performance Buildings 2007***

***Nashville, Tennessee  
18-20 April 2007***

***By  
Vijay K. Gupta, P.E., Fellow ASHRAE  
James E. Woods, Ph.D., P.E., Fellow ASHRAE***

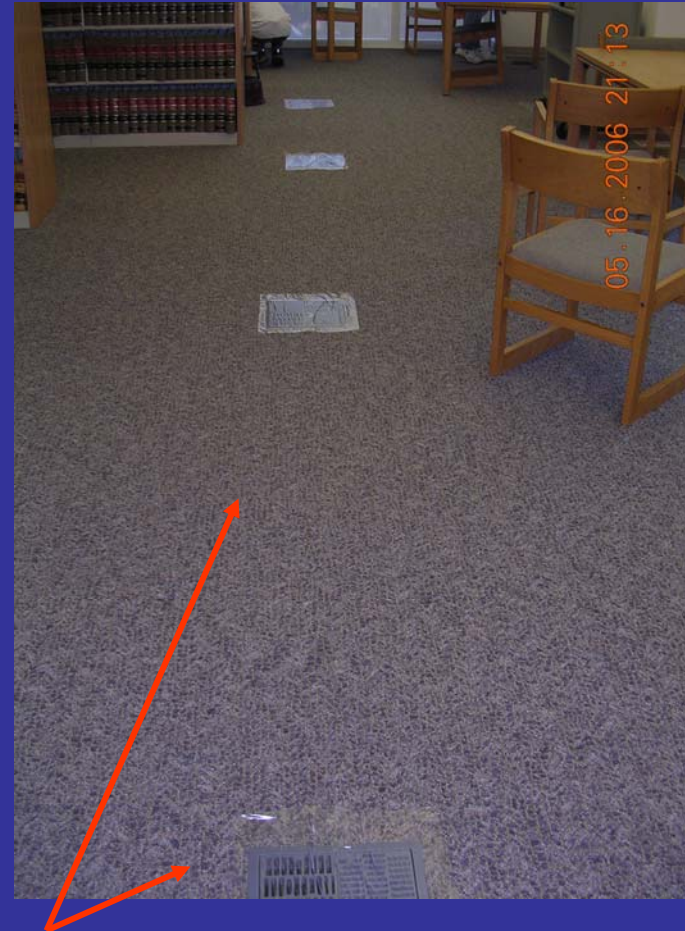
*View of Courthouse Library with diffusers taped for testing*

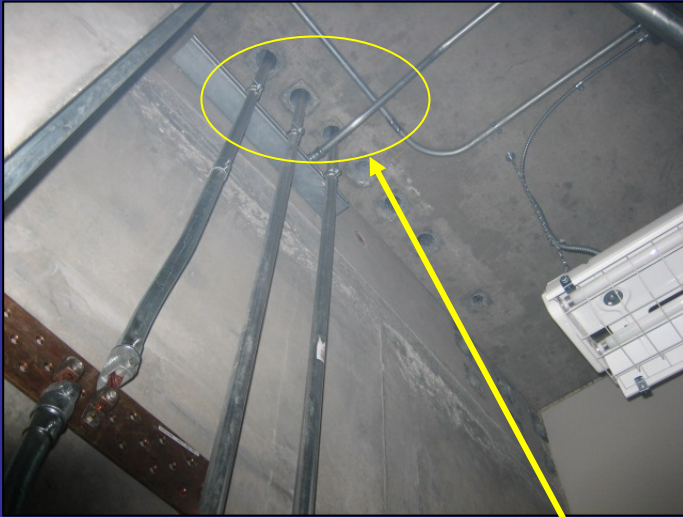
- *Leakage around and in annular spaces in conduit:*

*Conduit through floor slab to  
Space below UFAD*

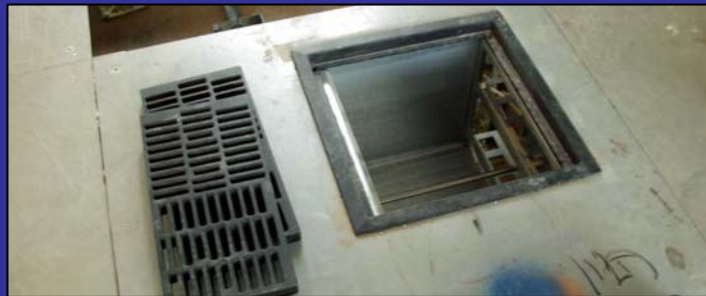
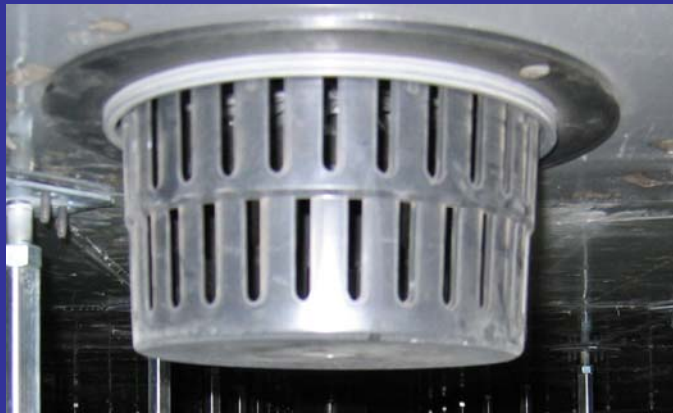
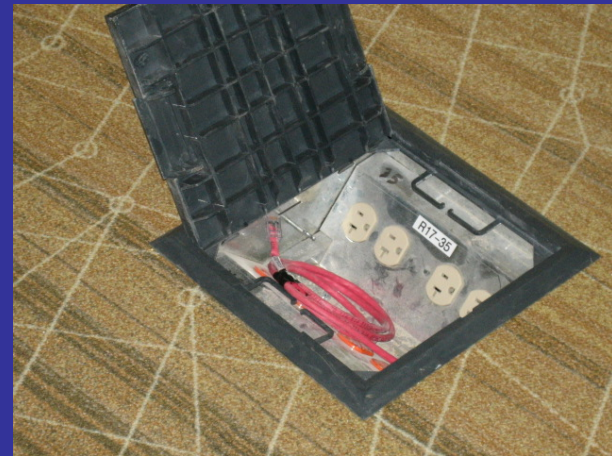
**Leaks of conditioned air from the plenum through components of the raised access floor system:**

- **Floor panel seams and edge closures**
- **Electric power connection and outlet service units**
- **Communications and data service units**
- **Air diffusers that do not close tightly**

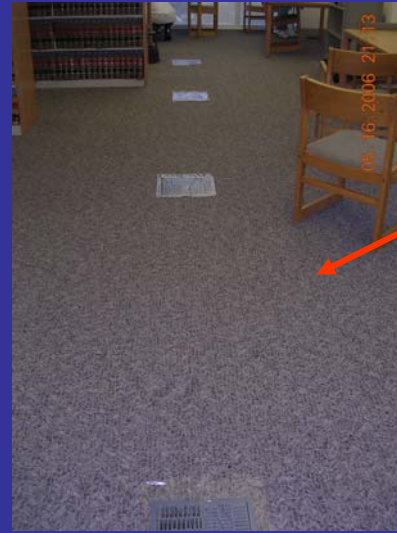
One of several  
Thermostatic zones  
Served by AHU

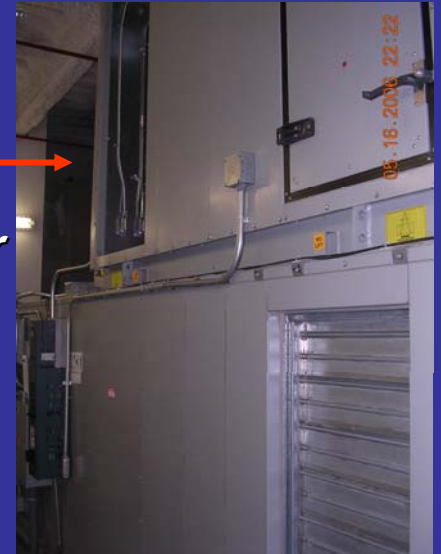
Typical AHU  
With VFD and  
Coil bypass for  
UFAD

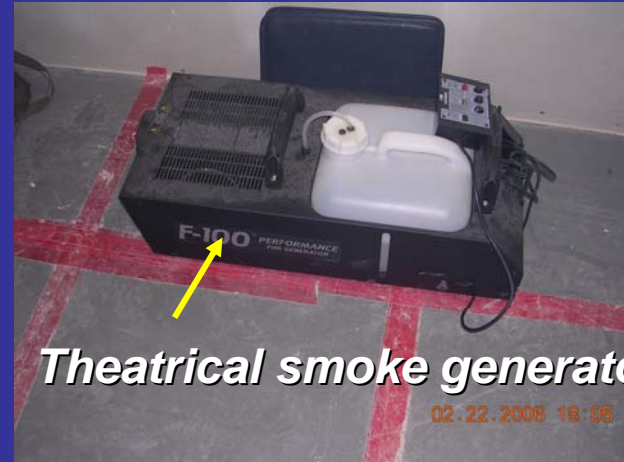
*Theatrical smoke generator*

- **Purpose: to locate air leakage pathways**
  - Conduct during Mockup Tests
  - For Permanent Systems Tests, conduct and purge during unoccupied periods
  - Use “theatrical” smoke generator (non-toxic)

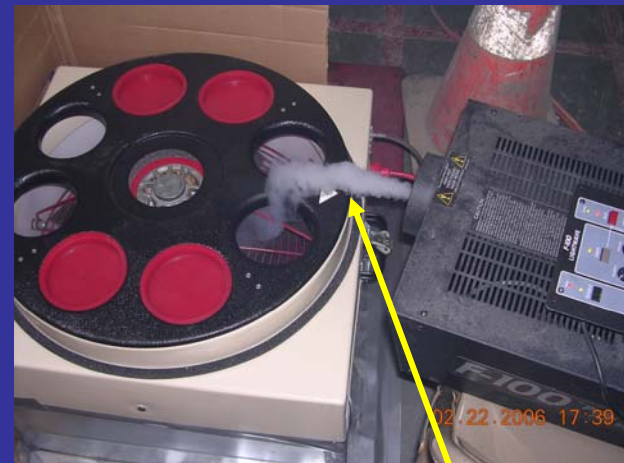
*Smoke induced into calibrated fan inlet*

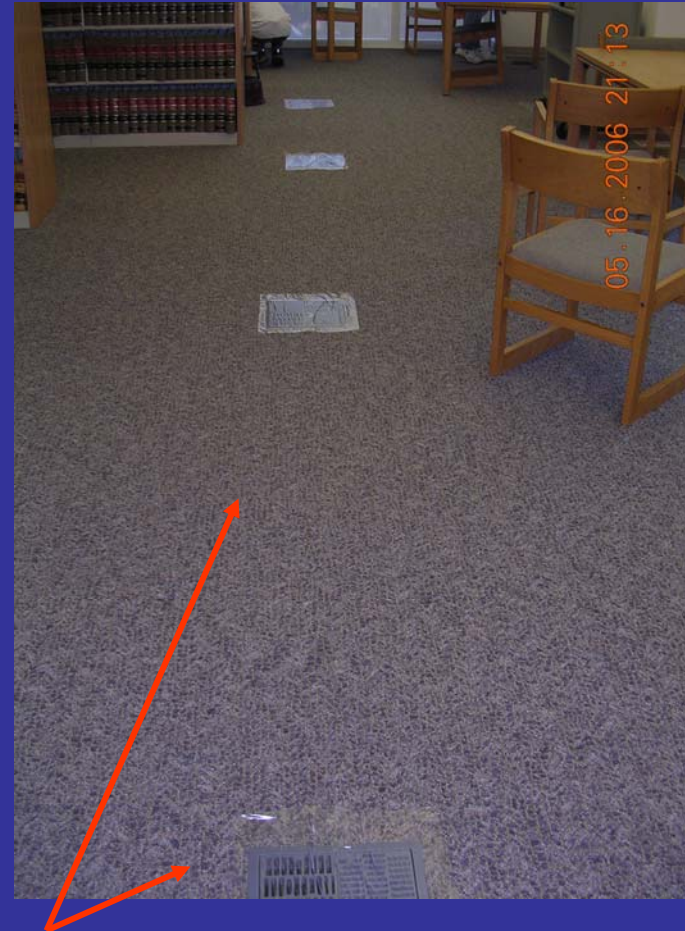
- Results of Air Leakage tests showed plenum leakage rates of 30 – 200% of design airflow rates at plenum static pressures of 0.07 in. w.g. (17 Pa)

*View of Library in FCH-1 with diffusers taped for testing*

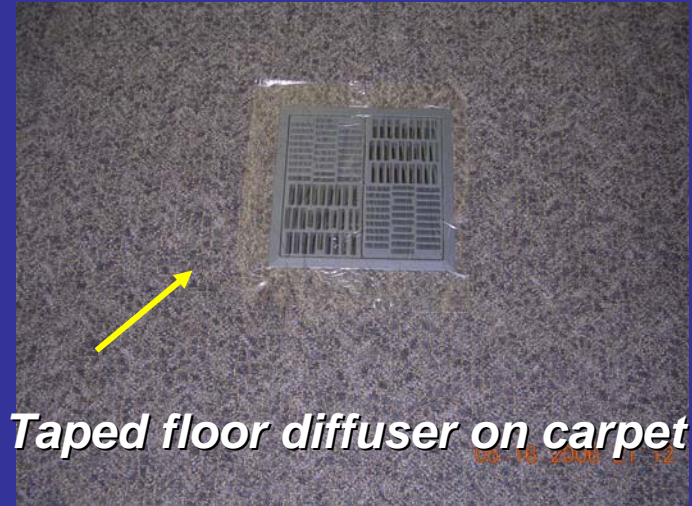
**Taped floor diffuser on carpet**

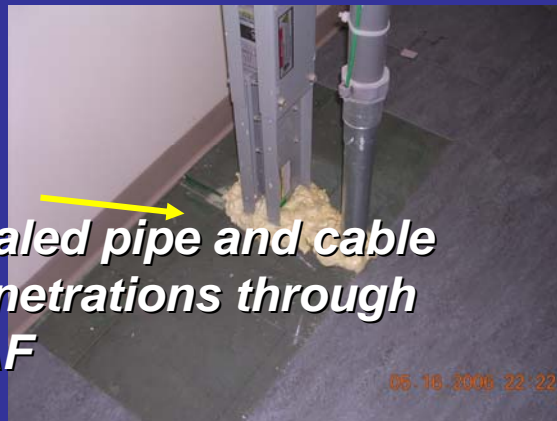
**Sealed pipe and cable penetrations through RAF**
